Blackwood Creek Reach 6 Restoration (Phase IIIA) Effectiveness Monitoring Results

UDSA FOREST SERVICE LAKE TAHOE BASIN MANAGEMENT UNIT

**Susan Norman, Craig Oehrli, Tim Tolley and Nicole Brill
January 2014**

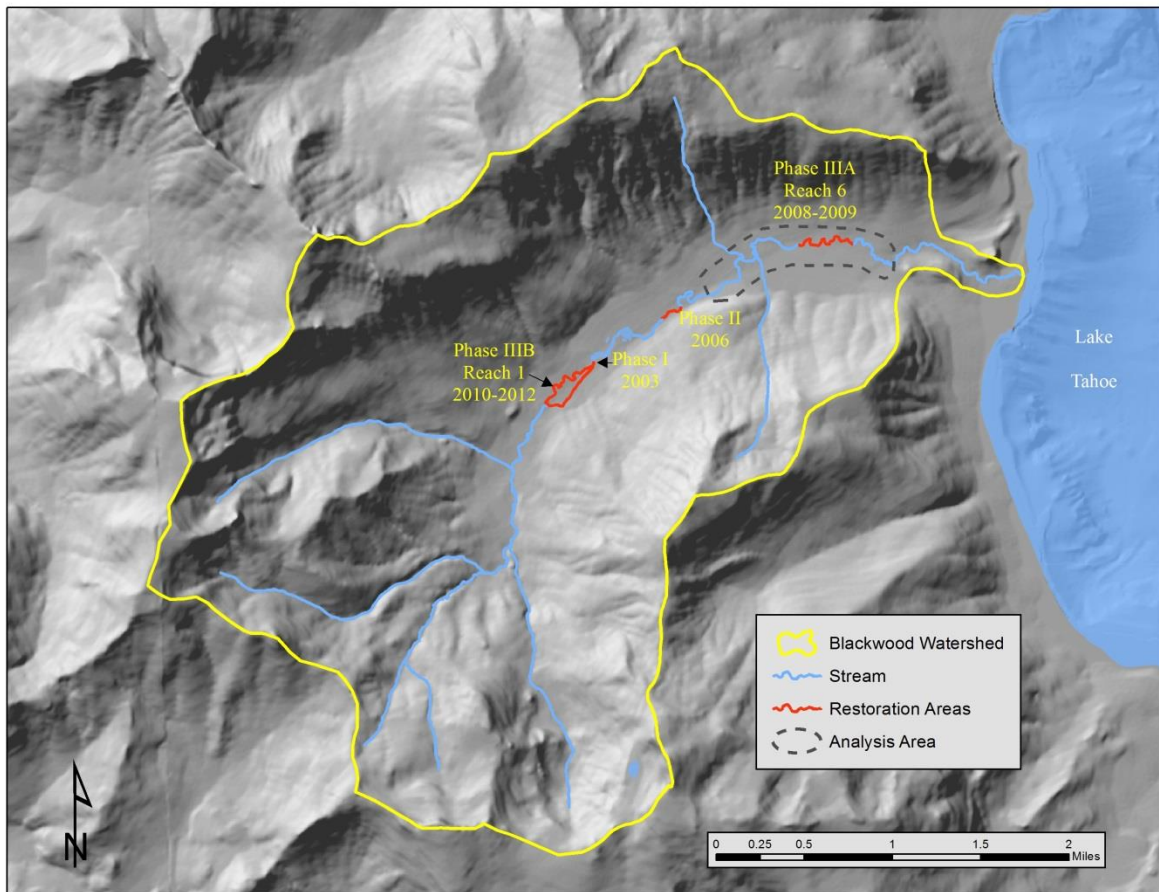
Figure 1: Blackwood Creek Restoration Project Areas

Restored Reach

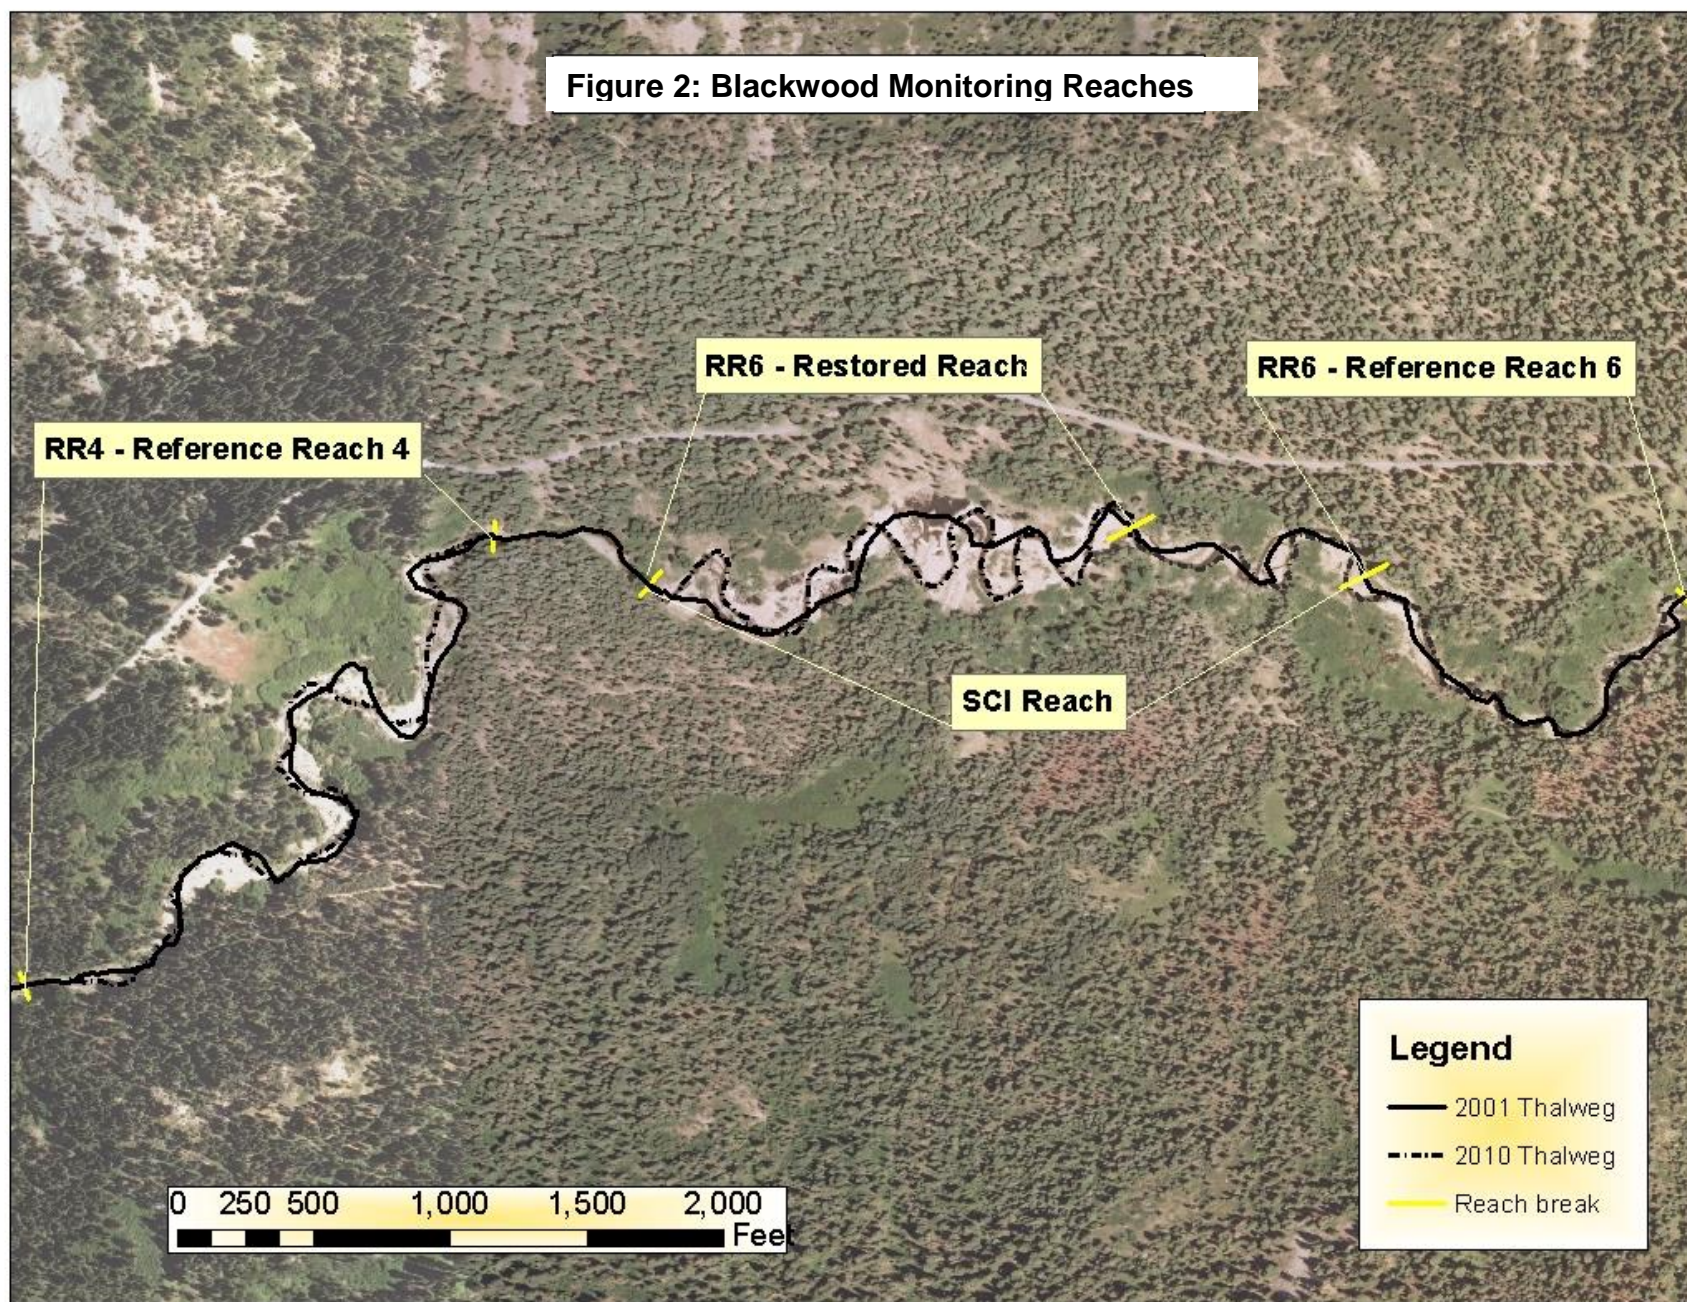
Figure 2: Blackwood Monitoring Reaches

Figure 2 below illustrates the location of the two reference reaches, the restored reach, and the previously established long term stream condition monitoring reach (discussed in more detail below). These methods include:

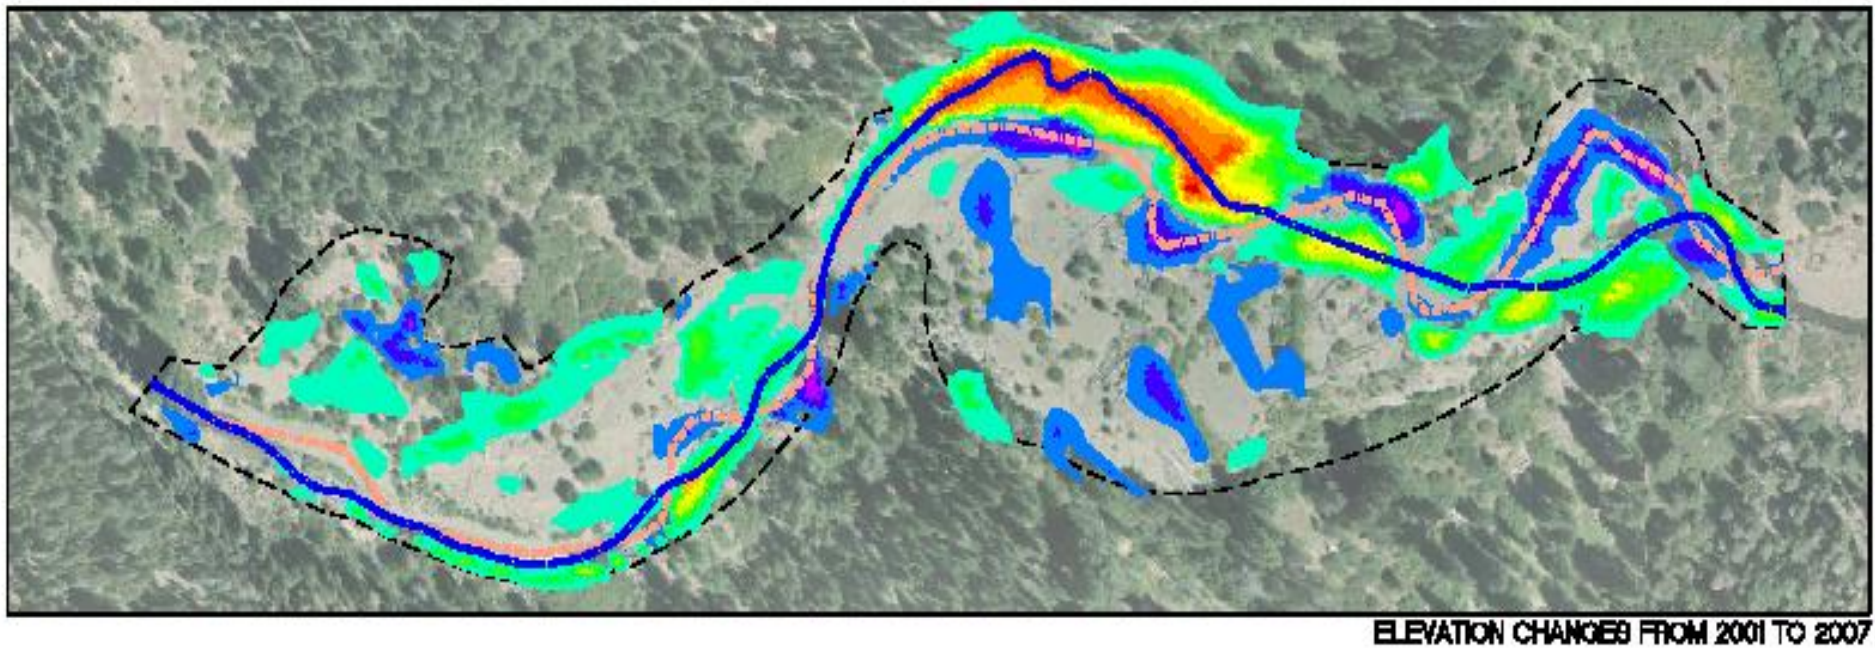
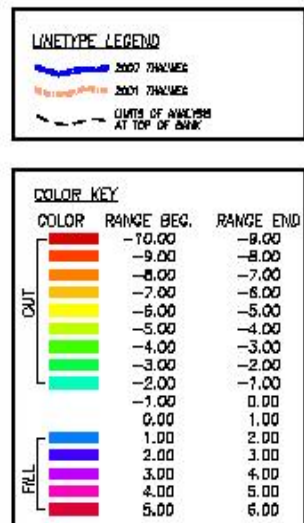
Figure A – Overall scour and fill between 2001 to 2007 at the Blackwood Reach 6 project site. Scour depth is shown in colors ranging from blue/green to red. Fill depth is shown in colors ranging from blue to pink. Mapping accomplished by overlaying the 2007 atop the 2001 project area digital aerial survey. Illustration provided to the LTBMU in 2008 by Swanson Hydrology and Geomorphology (unpublished).

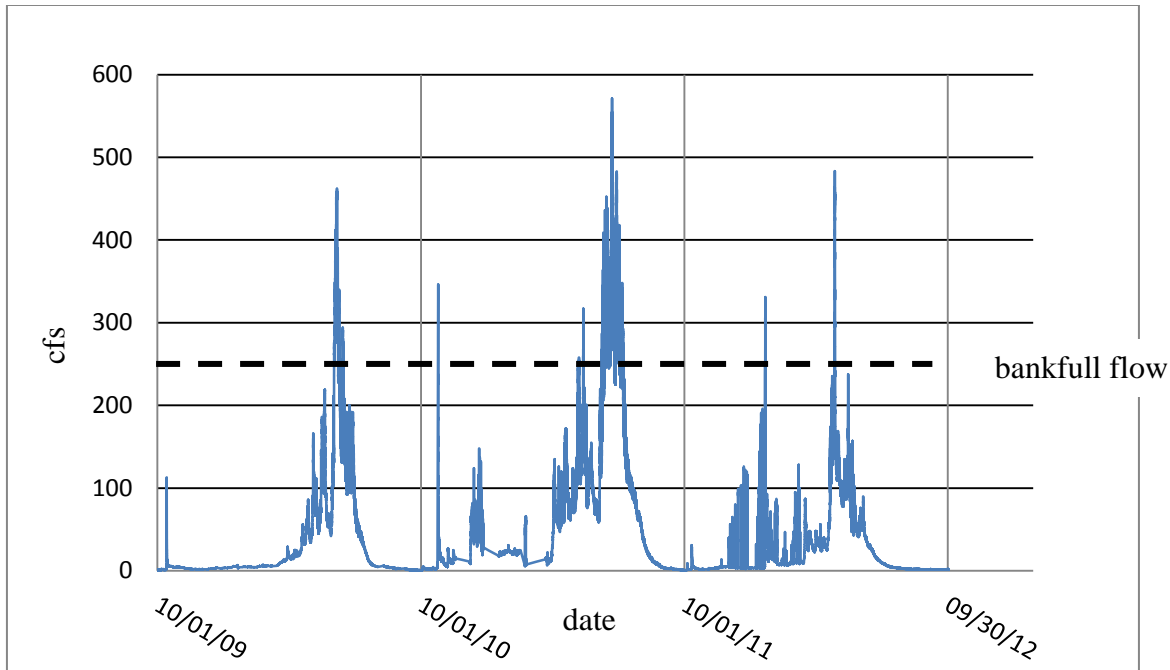
Figure 3: Blackwood Creek instantaneous 15 minute discharge at USGS station at mouth.

From the data illustrated in Figure 3, the restored reach experienced floodplain inundation for 18 days in WY 2010, 37 days in WY 2011, and 6 days in WY 2012 for a total of 61 days in the first three water years post construction. The variability in floodplain inundation is driven by precipitation, and from snowtel precipitation data measured at the NRCS Ward #3 site, the snow water equivalent (SWE) measured from the snowpack for these 3 years are considered to be average, above average, and below average respectively. It is estimated the entire constructed floodplain (excluding the constructed flow deflection structures) is inundated at approximately 600 cfs flows as measured at the Blackwood Creek LTIMP stream gage. The pictures on the following pages illustrate the degree of constructed floodplain inundation during several site visits.

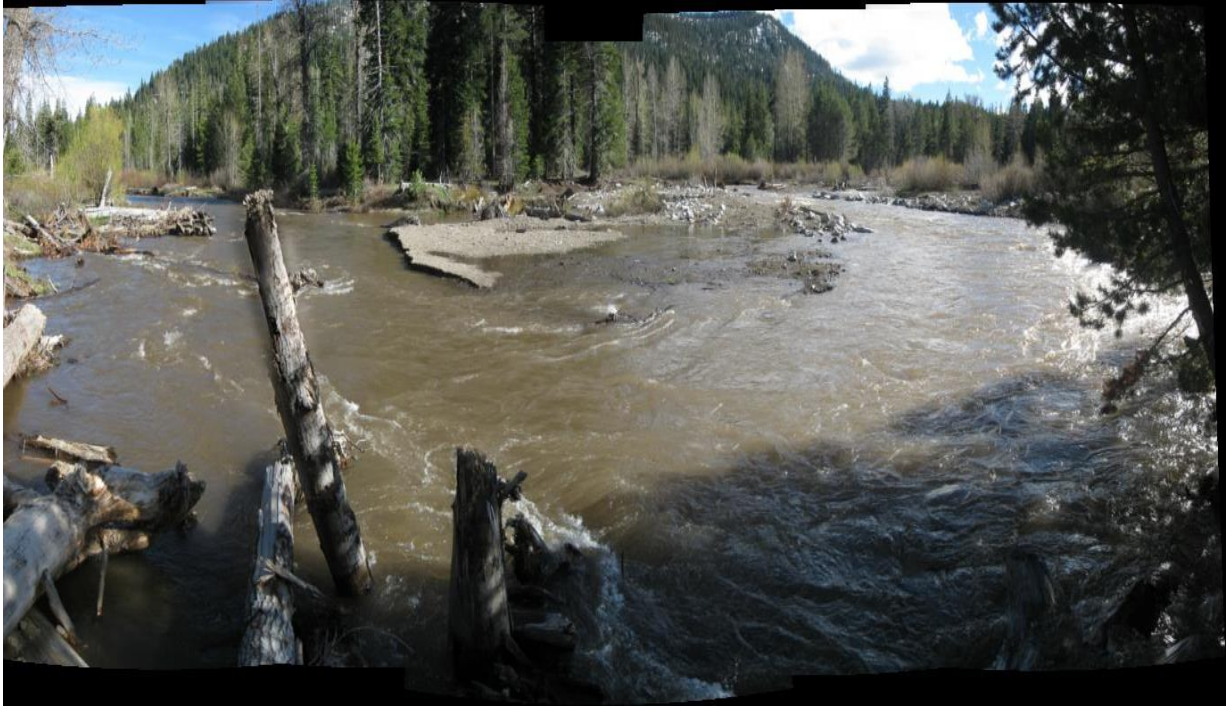
Figure 4: Flood flows in restored reach on June 7, 2010 at approximately 440cfs.

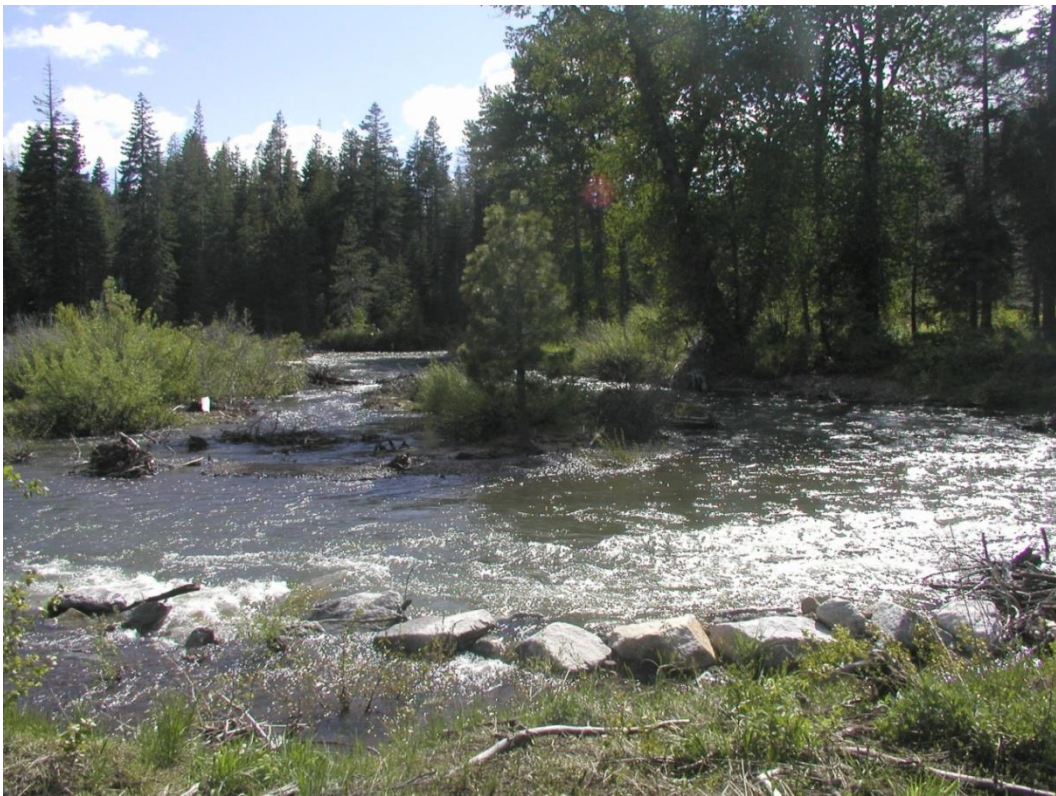
Figure 5: Flood flows in restored reach on June 29, 2011 at approximately 350 cfs.

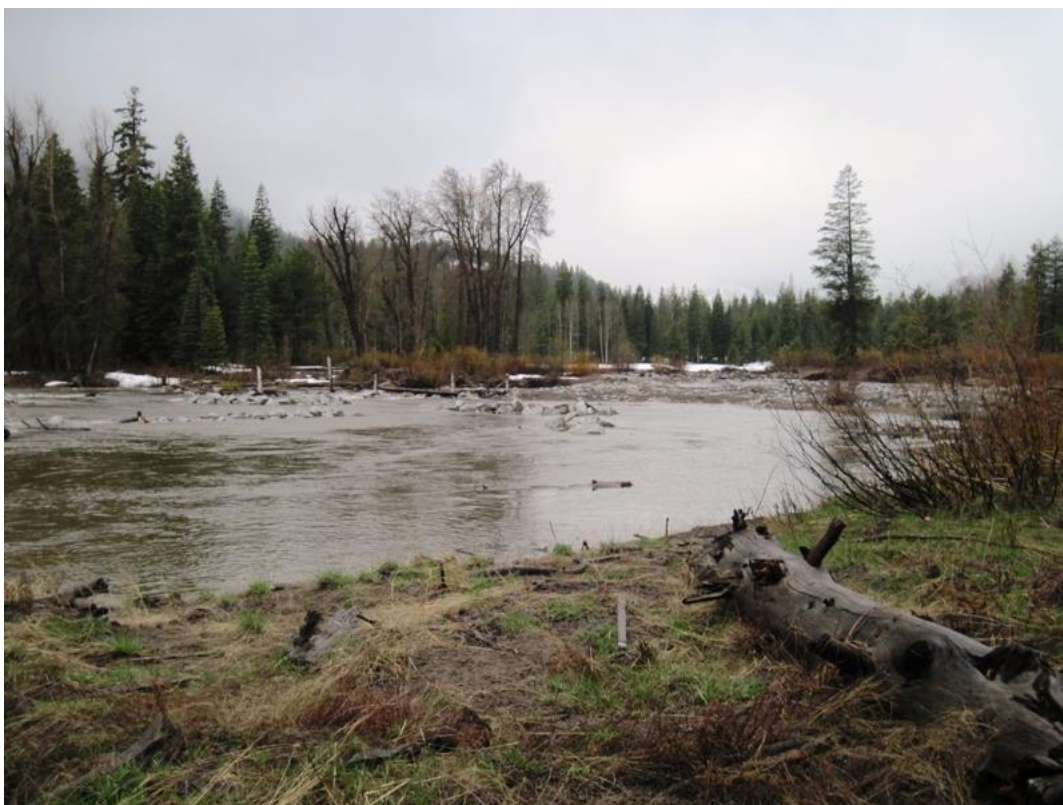
Figure 6: Flood flows in restored reach on April 26, 2012 at approximately 480 cfs.

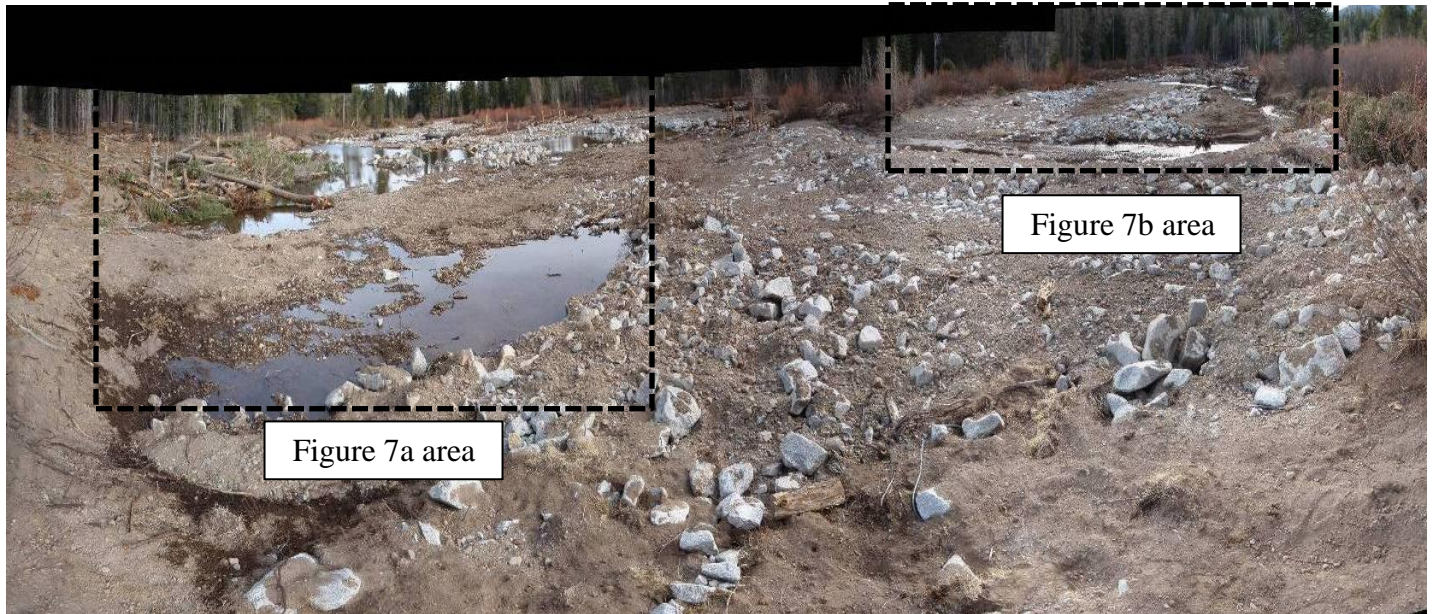
Figure 7: Constructed Floodplain immediately post project (11/9//2009)

Post project effectiveness monitoring will be repeated every 5 years after restoration, so no quantitative post project effectiveness data is reported at this time. Visual observations and photos (illustrated in Figures 5 and 6 below) indicate that many of the willow stakes planted as part of restoration appear to be taking hold and more importantly graminoids and woody vegetation recruitment are beginning to appear in areas where fine sediment has deposited on floodplain surfaces. Salvaged woody riparian vegetation also survived the process of transplanting. This is illustrated in the photo points presented in Appendix D. One of the most dramatic areas of this transformation is illustrated in the photo sequence presented below. In this area, the elevation of the floodplain was approximately 2 feet below the desired grade because of the impacts of equipment used for temporary staging of rock material. The restoration design incorporated features to create a stable backwater in this area, so that high flows (and associated sediment transported from the upper watershed) would rapidly build up the floodplain in this area. The degree of deposition is discussed further in the next section, but the photos below illustrate the vegetation response in this area. The 2009 photo (Figure 7) is a panorama composite; the 2012 photos (7a and 7b) are standard format photos, located in the approximate area of the inset dashed boxes in the 2009 panorama in Figure 7. Photo 7c, illustrates a

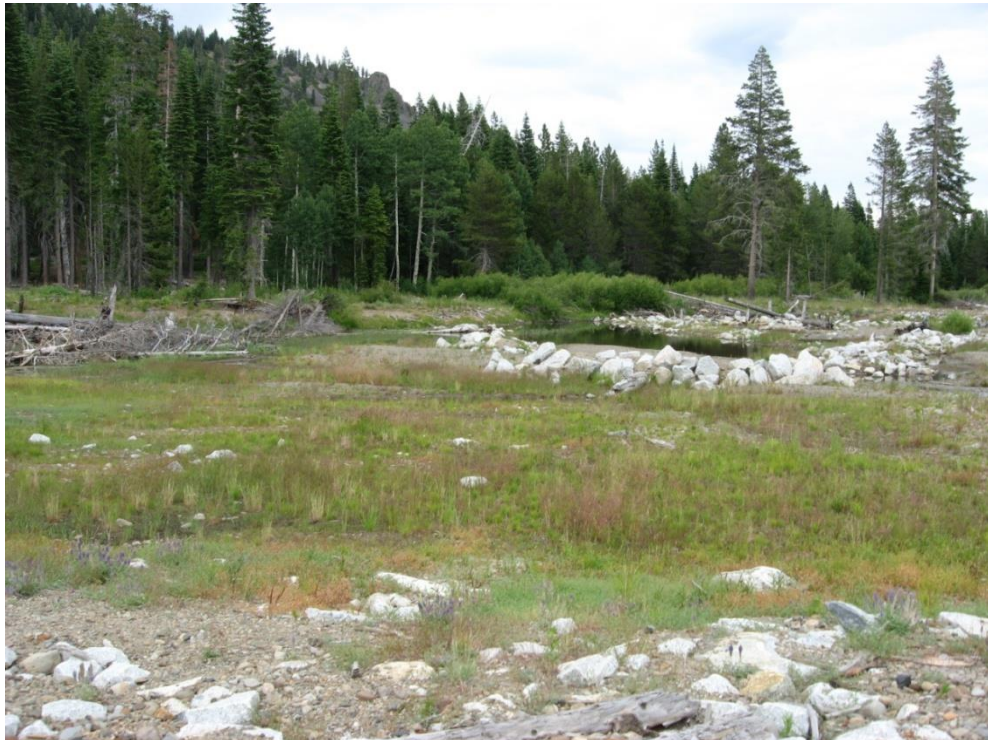
Figure 7a: Inset photo shown in Figure 7, riparian grass colonization and sediment deposition, three years post project in constructed floodplain (July 2012).

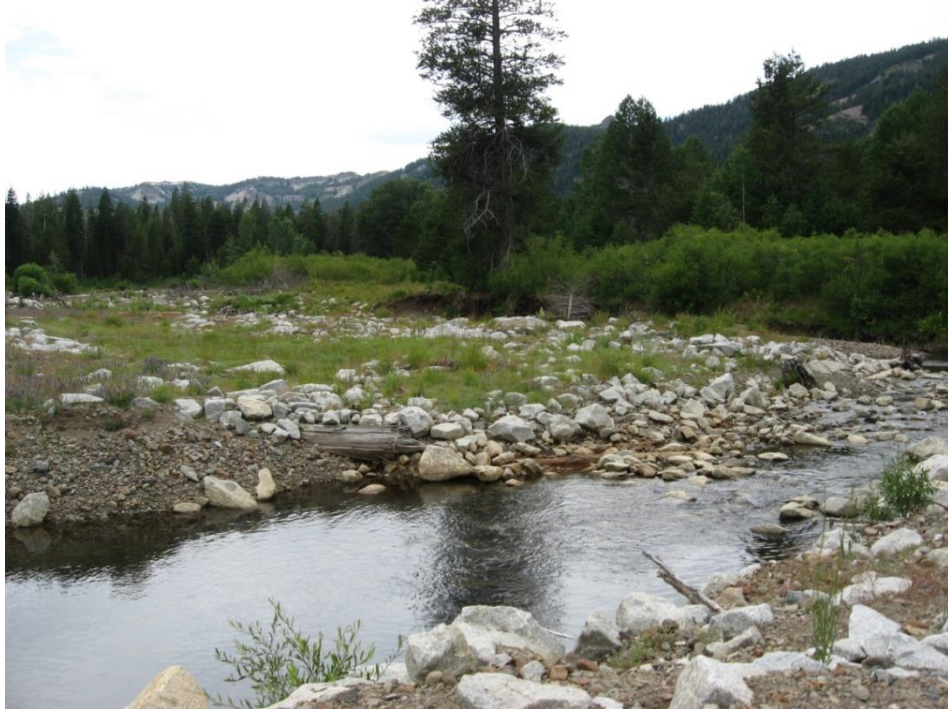
Figure 7b: Inset photo shown in Figure 7, riparian grass colonization and sediment deposition, three years post project in constructed floodplain (July 2012).

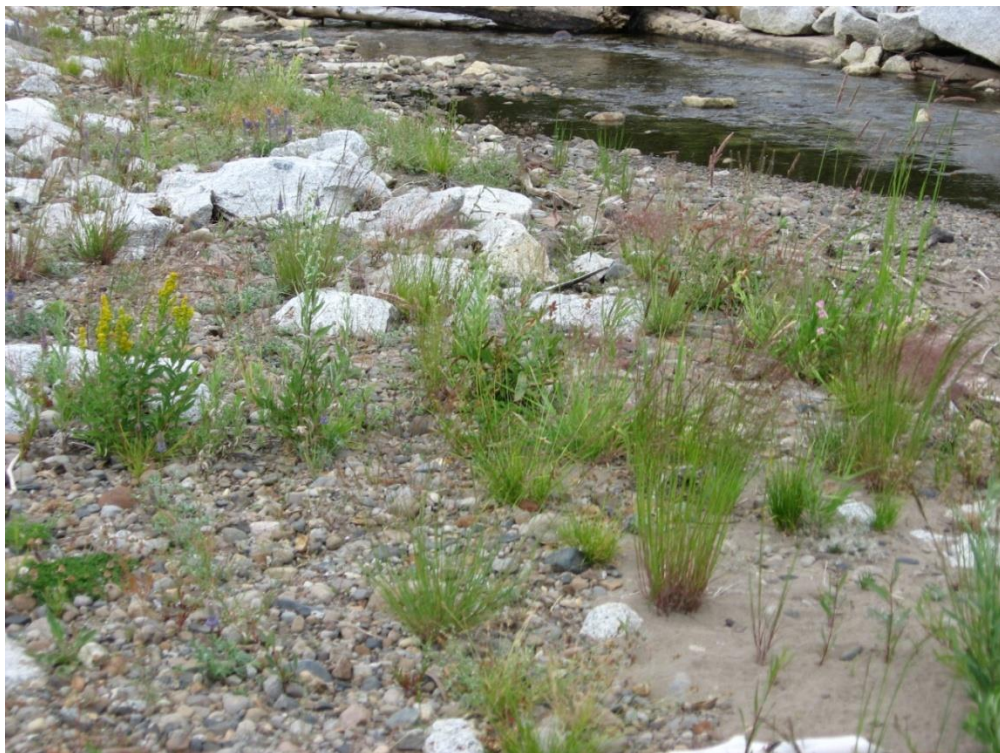
Figure 7c: Graminoid growth within constructed floodplain/channel banks (July 2012).

close up of the types of vegetation appearing within the more cobble dominated substrate along the channel margins.

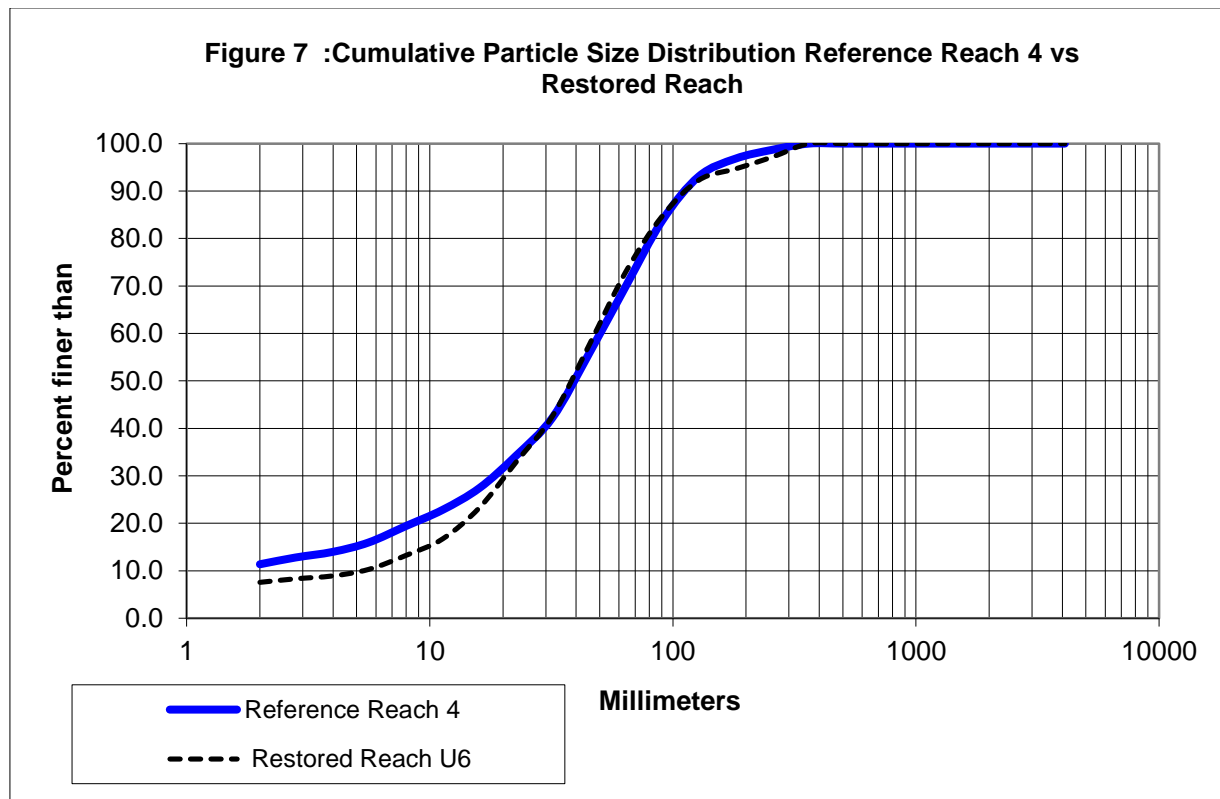
Figure 8: Cumulative Particle Size Distribution Reference Reach 6 vs. Restored Reach

The particle size data was analyzed to determine particle size classes and plot cumulative particle size distributions. Figures 7 and 8 display the cumulative particle size distributions in the restored reach compared to the two reference reaches in 2011. Figure 9 displays this information for the pre-project data collected in the SCI reach in 2003 compared to the restored reach 2011 data.

Figures 7 and 8 indicate that the particle size distributions are very similar between the restored reach and the two reference reaches. The percentage of particles less than 10 mm (medium gravels or smaller) in size is slightly higher (20% compared to 15%) in the reference reach 4 when compared to the restored reach.

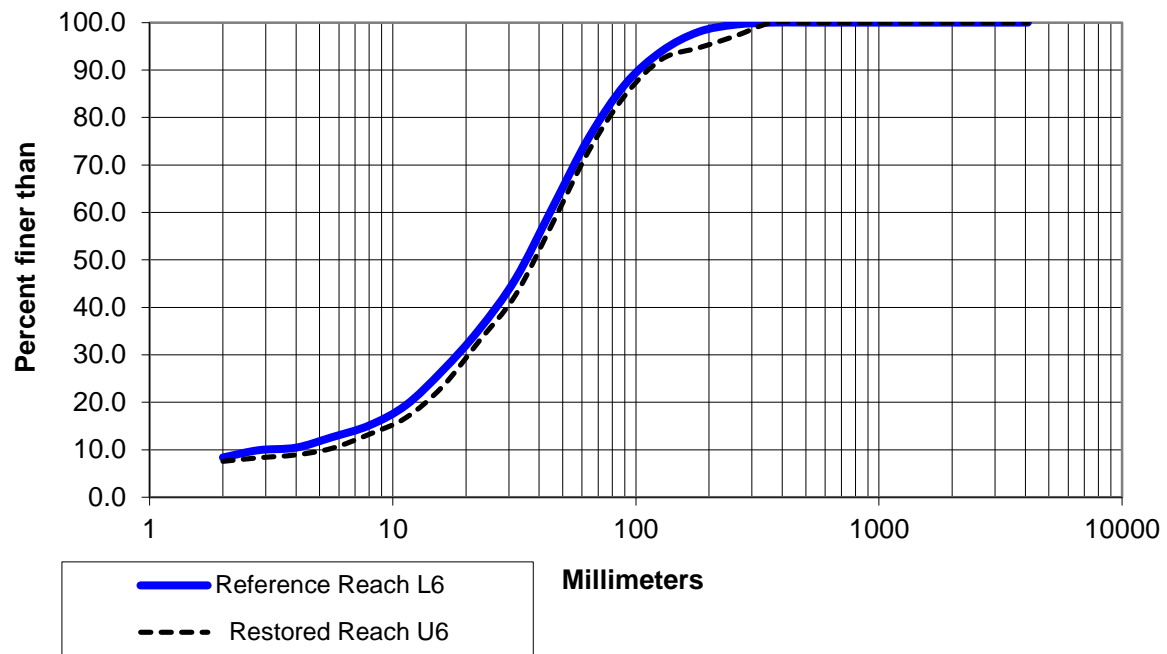
Figure 9: Cumulative Particle Size Distribution Pre and Post restoration in Restored Reach

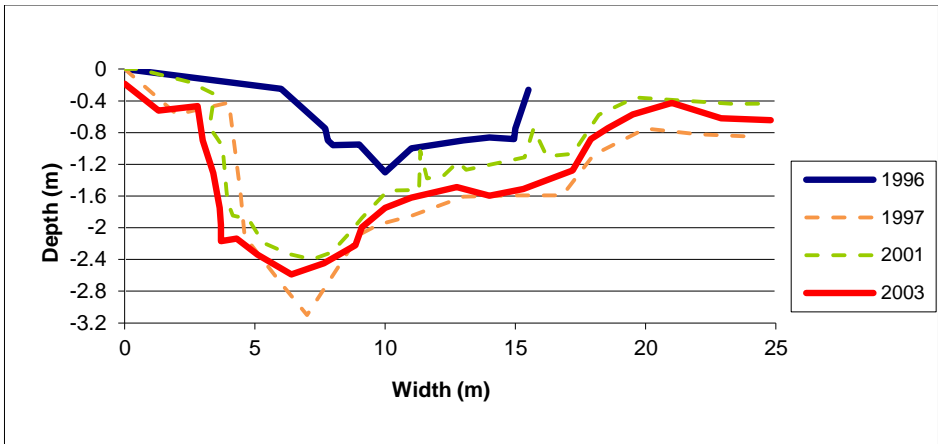
Figure 10: Blackwood Creek Cross Section #2

Long term permanent cross sections in the SCI reach are a very striking piece of data documenting channel incision and floodplain loss as Blackwood Creek destabilized. The locations of these cross sections are illustrated in Appendix B2. Changes in Blackwood Creek XS-2 (shown below), located approximately 150 meters downstream of the restored reach, are characteristic of changes occurring at all six long term permanent cross sections (Appendix F) in the SCI reach. These graphs illustrate the dramatic change that occurred as a result of the rain on snow peak flood event during the winter of

1996/1997. The magnitude of floodplain loss (~10 meters) documented at this cross section after the 1997 flood, is actually small in comparison to what was visually observed in the project area after this flood (losses of ~30 meters or more).

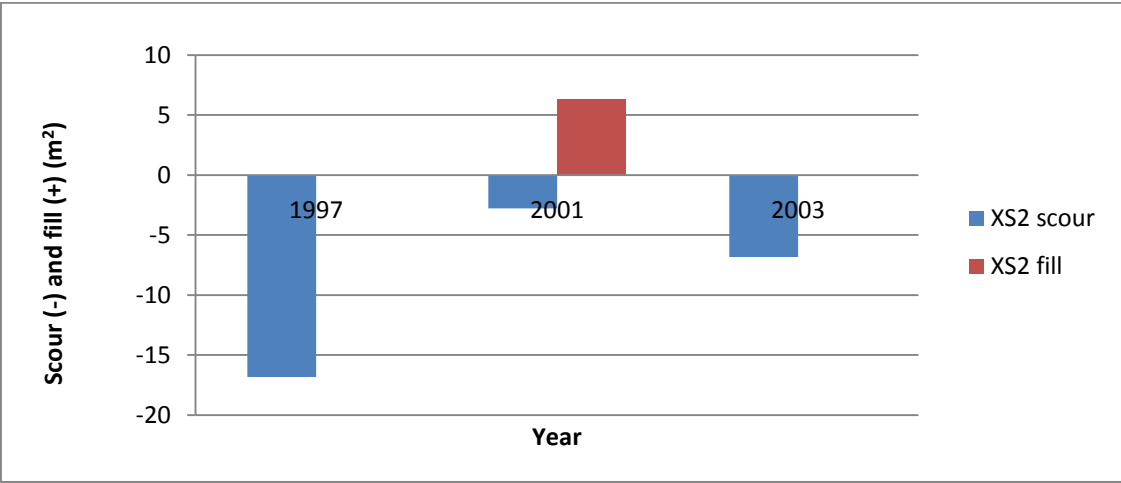
Figure 11: Blackwood Creek Cross Section #2 Erosion and Deposition

Total scour at cross section #2 was 53 square meters. In comparison only 6 square meters of deposition was measured. This cross section analysis provides a representative snapshot of the nature of channel erosion and deposition between 1996 and 2003, and in particular as a result of the 1997 flood.

Figure 11 below illustrates the total cross sectional area of channel scour and fill between 1996 and 2003 at cross section #2, and scour (erosion) and fill (deposition) at the other 5 cross sections are presented in Appendix F.
